# **Measuring the effectiveness of Nature-Based Solutions (NBS) in relation to the objectives of the Climate Action Plan for Destination Tourism of Dugi Otok Island**

Final Report

May, 2026

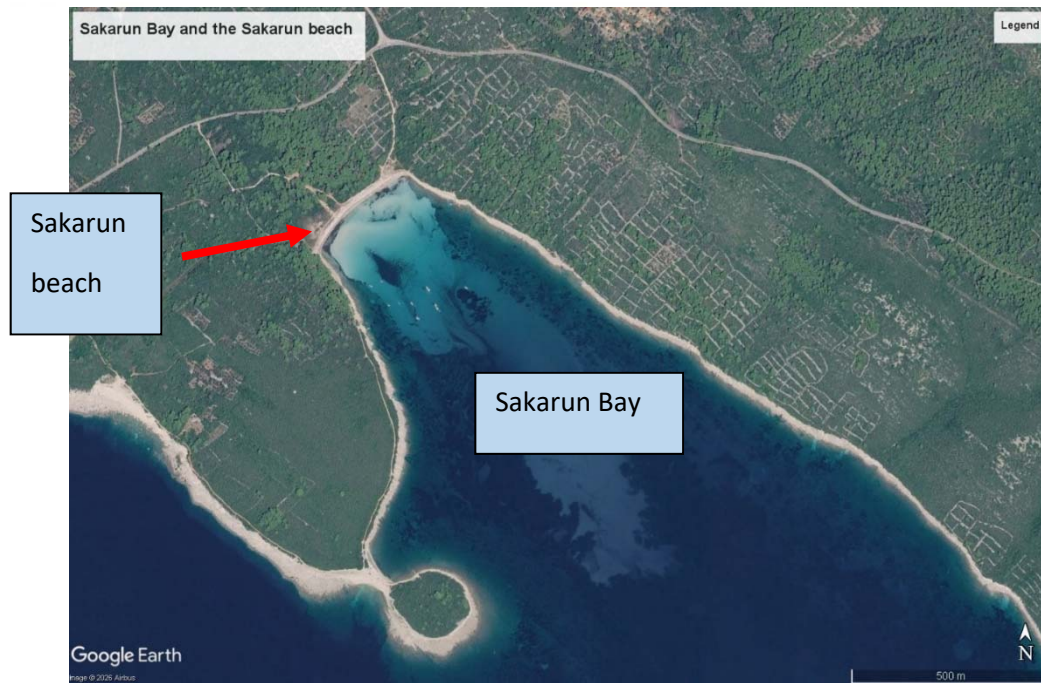
**Figure 2:** Sakarun Bay and the Sakarun beach. Source: Google Earth 2026.

Sakarun Bay is a 900 m long and 700 m wide indented bay, with the beach of the same name located at its north-western end (Figs. 2 and 3). The beach is a 300 m long pocket beach, oriented south-east and directly exposed to Sirocco (SE) wind waves, mostly of shore-normal incidence. It is a pebble beach, typical of Croatian coast. However, a narrow strip of sand regularly occurs along the seaward part of the beach. These subaerial and the intertidal sands are generally very well sorted, slightly gravelly sands or pure sands with a mean grain size of about 0.2 mm. This sand is entirely biogenic carbonate sand of marine origin (Godec, 2021; Pikelj and Godec, 2021; Pikelj et al., 2022). It is composed of crushed shells and skelets of mostly invertebrate organisms, such as molluscs, foraminifera, bryozoans, echinoids, etc. (Godec, 2021; Pikelj and Godec, 2021; Pikelj et al., 2022). Such sediment characteristics indicate continuous wave action. Sediment with similar characteristics occur in the deeper parts of the bay (Pikelj, unpublished data). The rest of the bay's coast is rocky and highly affected by strong marine erosion. The described white sand and rocks, and dark-green surrounding vegetation further emphasise the attractive turquoise colour of the seawater. Therefore, Sakarun Bay and Sakarun beach attract many tourists during the summer, including both beachgoers and nautical tourists.

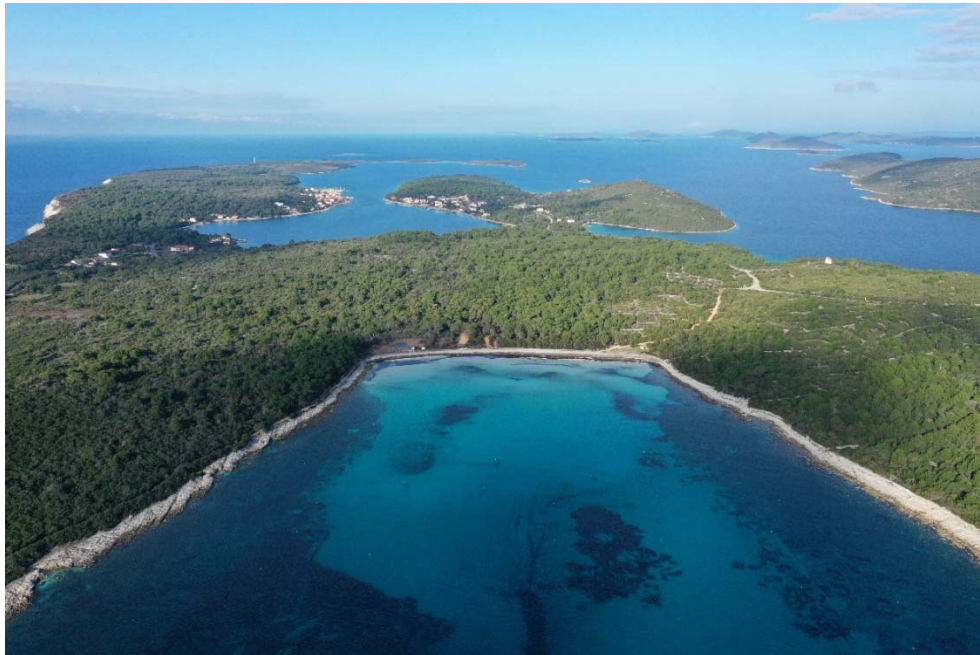
**Figure 3:** Sakarun beach – aerial view. Natural Bridge is far in the distance (December 2025).

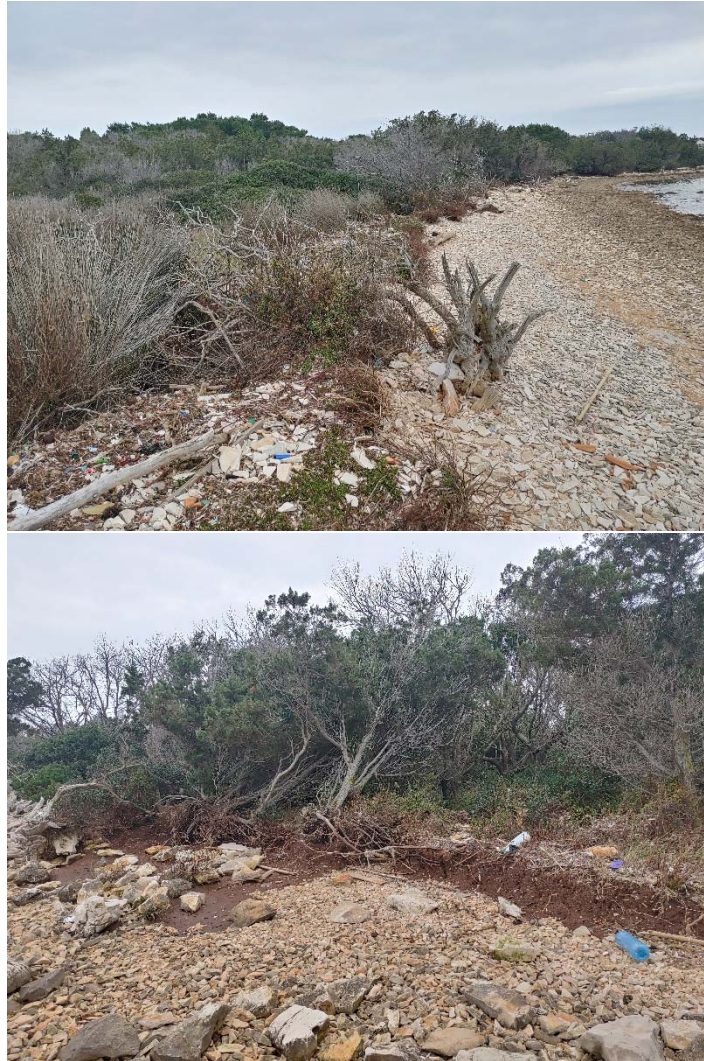
**Figure 6:** Abrasive effect of angular pebbles in the Pantera Bay coast (February 2024).

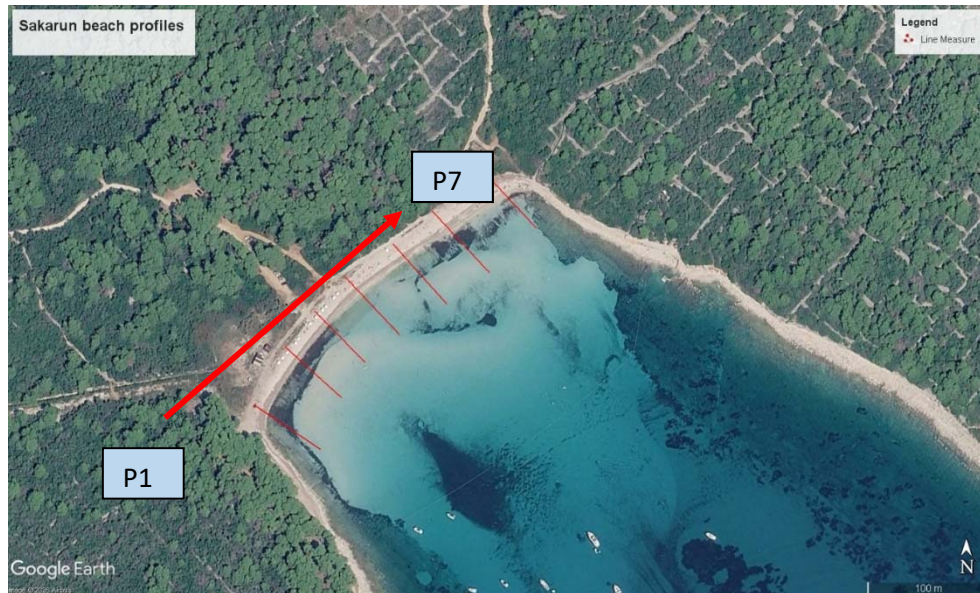
**Figure 10:** Position of the profiles on the Sakarun beach (Google Earth 2026).

Profiling on Sakarun beach was carried out on seven profiles established in 2021 (Pikelj, 2021a). The profile numbers increase from southwest to northeast (Fig. 10).

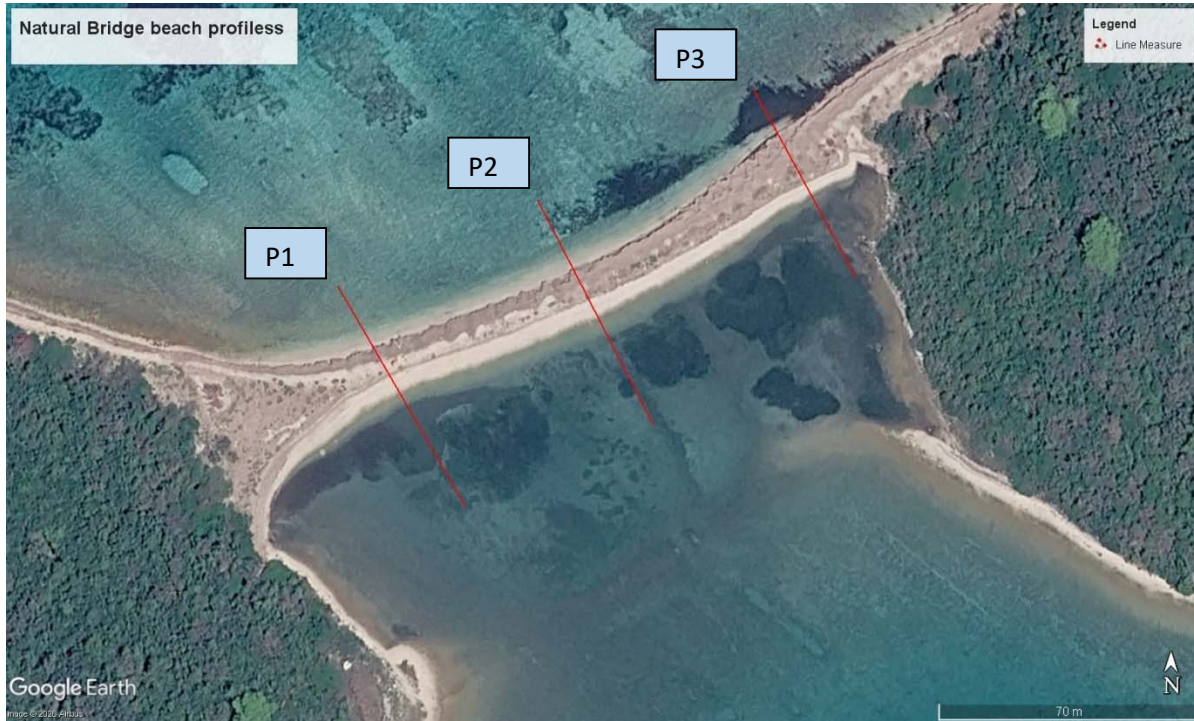
**Figure 11:** Position of the profiles on the Natural Bridge (Google Earth 2026).

The same principle was applied to Natural Bridge beach; however, due to the specific shape of the beach (it is longer on the outer side and shorter on the inner side), only three profiles were selected for beach profiling. These profiles were positioned to start in the Pantera Bay, cross the beach, and end in the sea (Fig. 11). Profile visualization was made using MS Excel, with each profile compared individually across all survey dates.

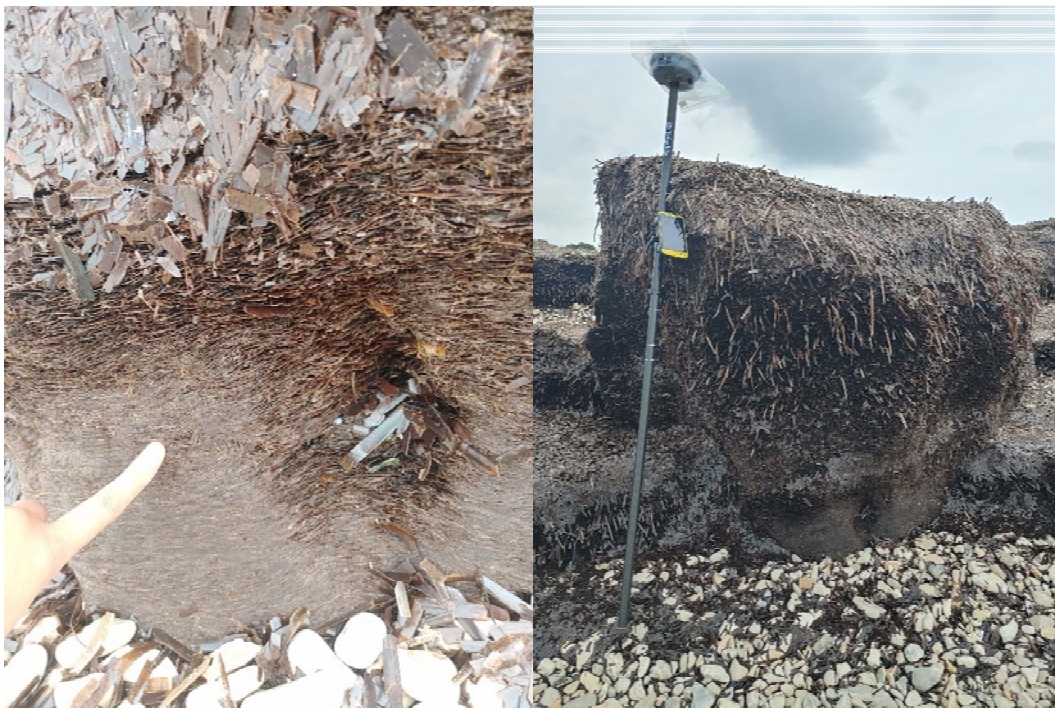
**Figure 37:** Banquette on the Natural Bridge “shaved” by pebbles raised by waves.

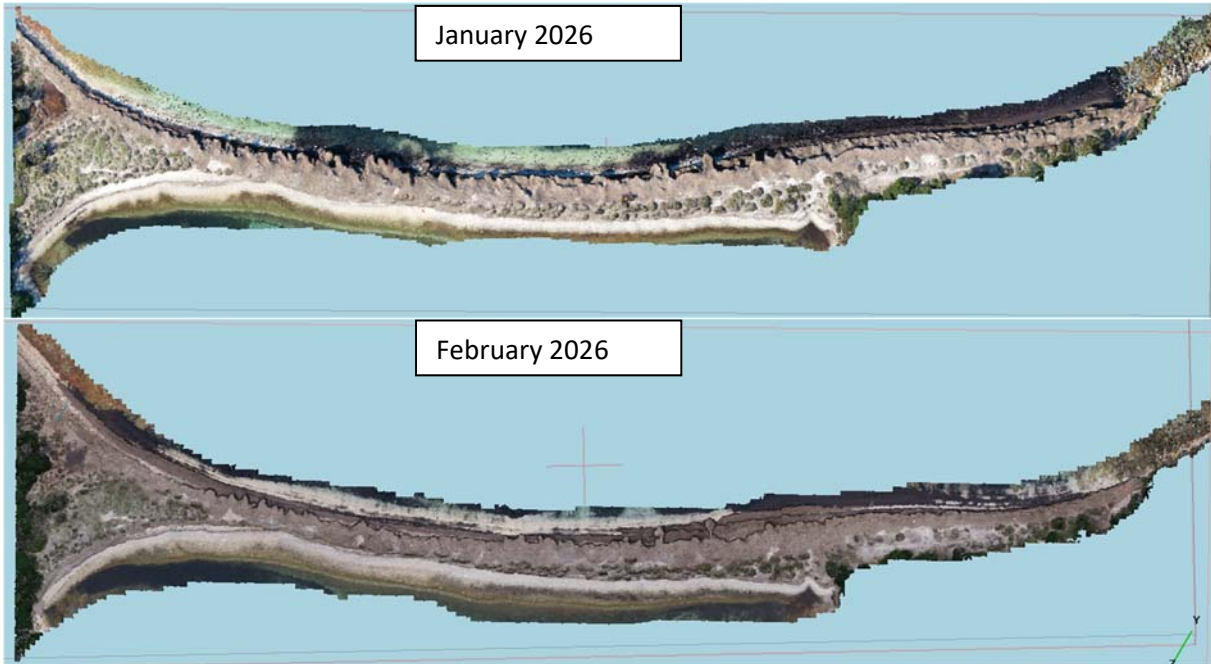
**Figure 47:** Dense point clouds of the Natural Bridge beach: January 2026 and February 2026.

**Figure 48:** 3D models and the model of differences for monitoring period January-February 2026.

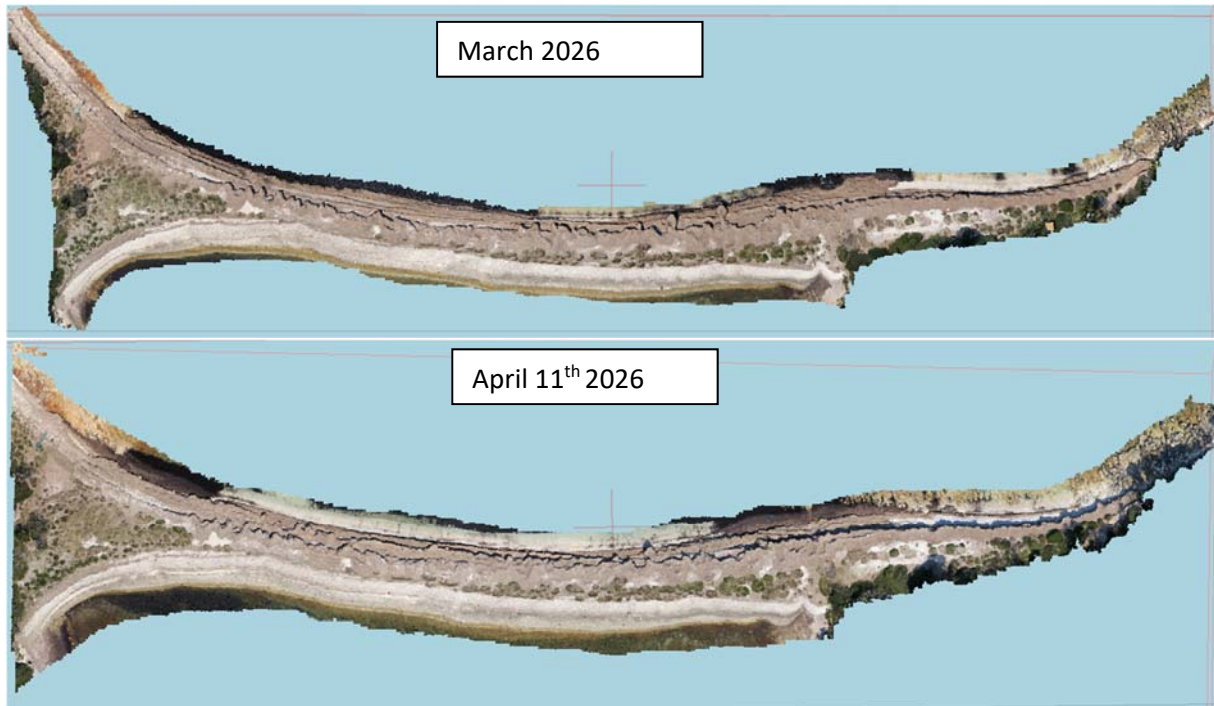
**Figure 51:** Dense point clouds of the Natural Bridge beach: March 2026 and April 2026.

**Figure 52:** 3D models and the model of differences for monitoring period March 2026 – April 2026.
